## **AHERA Asbestos Management Plan**

**Grigsby Intermediate School**  
100 Jamaica Road  
Carlisle, Ohio 45005

**Carlisle Local Schools**  
724 Fairview Drive  
Carlisle, Ohio 45005  
(937) 746-0710

**Report Date: October 14, 2016**  
**Project Number: 16-068-001**

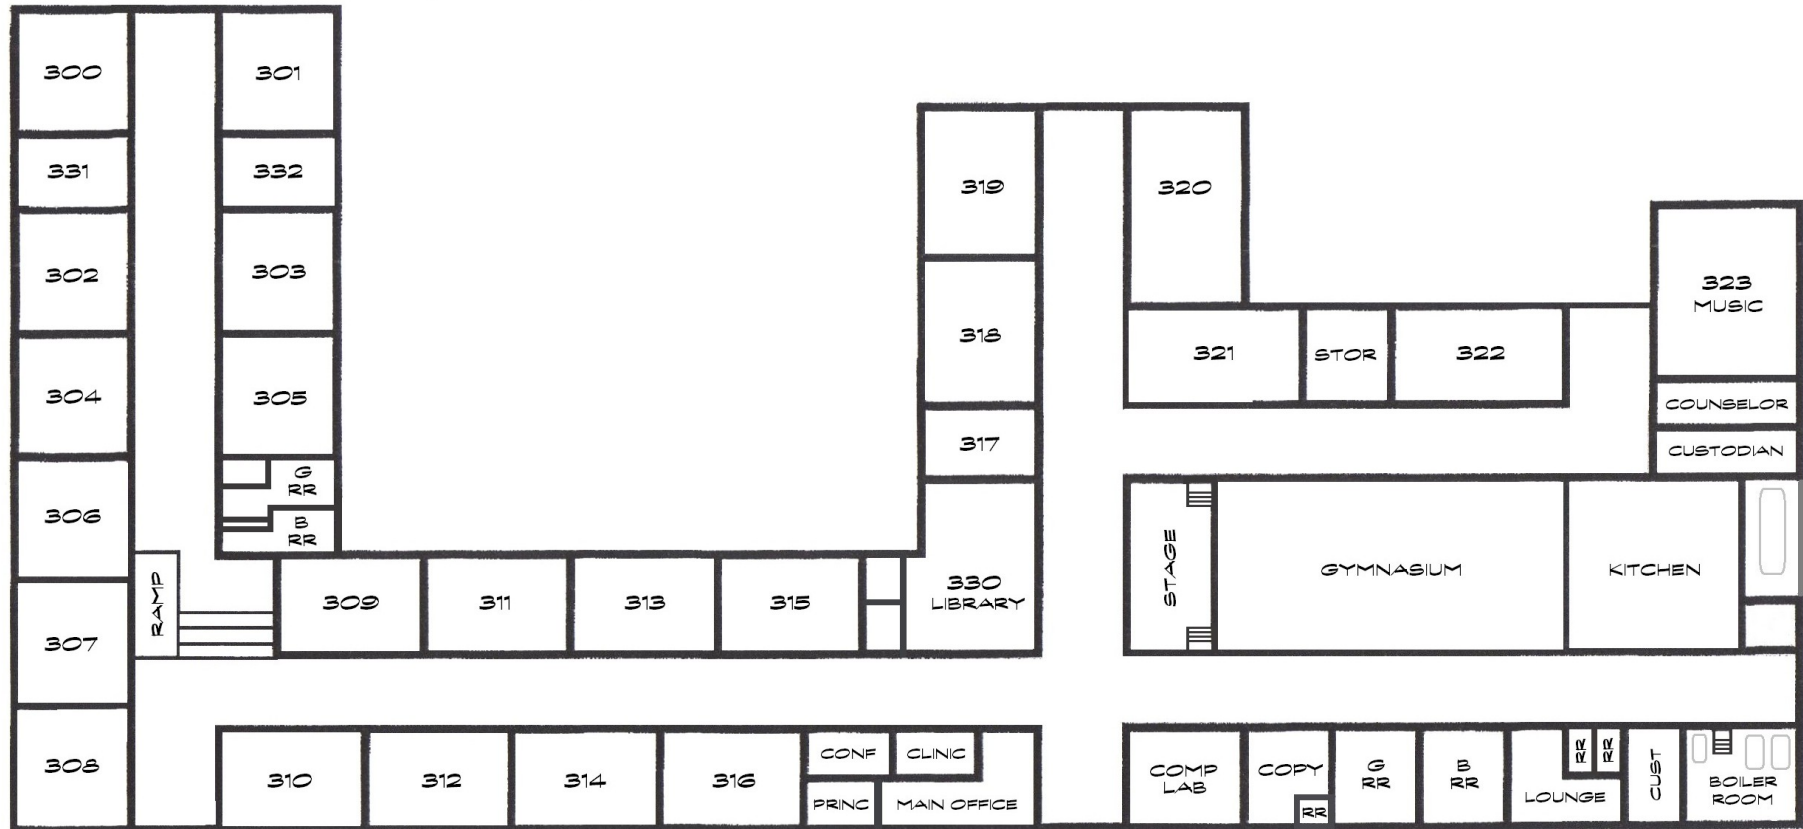
**BUILDING FLOOR PLANS**

The use of this building floor plan is intended to determine the locations of functional spaces as described on the AHERA Re-Inspection Assessment and Recommendations Summary included in Attachment B of the Inspection/Management Plan Report. This summary includes: the type, description, location, estimated quantity, friability, current condition, potential for damage, and recommend response actions, if any, for each friable and non-friable known or assumed ACBM within the building.

<b>Building Floor Plans</b> <b>Grigsby Intermediate School</b> 100 Jamaica Road, Carlisle, Ohio 45005		
Description: 1st Floor		Drawn By: MBL
Project #: 16-068-001	Date: October 14, 2016	<b>PAGE</b> <b>1</b> <b>OF</b> <b>1</b>
 	35 Compark Road, Suite 203 Dayton, Ohio 45459 (937) 751-7872 <a href="http://www.daytontesting.com">www.daytontesting.com</a>
